# REMINGTON 105CTI II NO. 81031 3-INCH 12 GAUGE, \$1559

## GUN TESTS GRADE: F

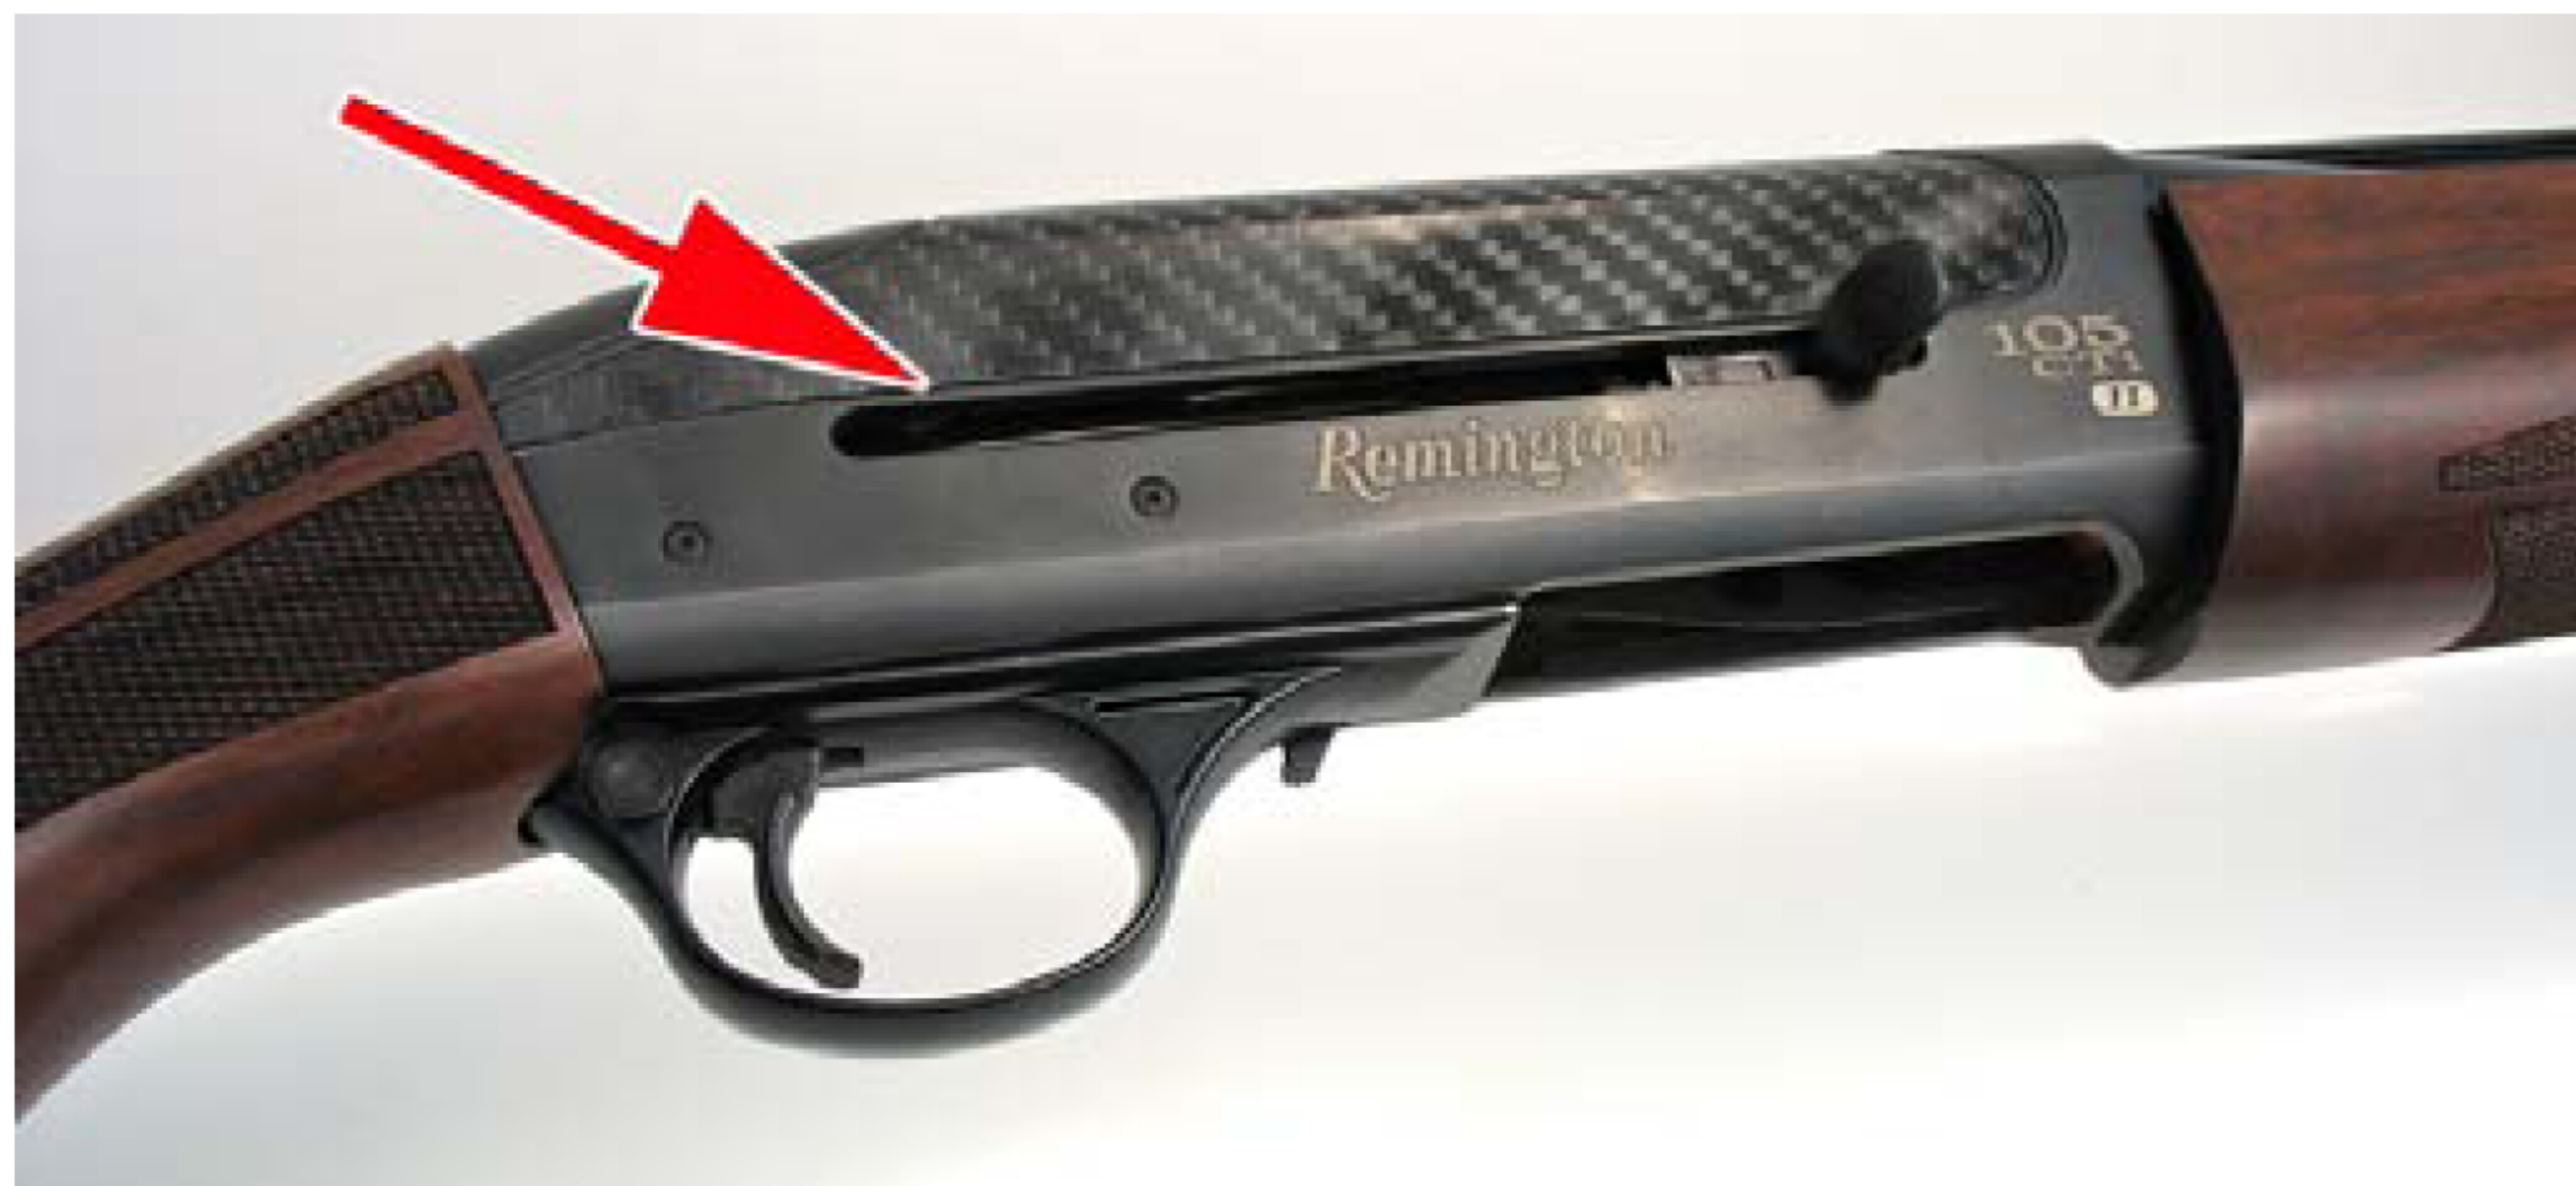
While the bottom ejection can be considered a plus for inhibiting the entry of foreign material into the action, the overly large slit in the side of the action is a significant entry point. The skeletonized receiver of the 105CTi II has a shimmery “fish lure” type finish to it.

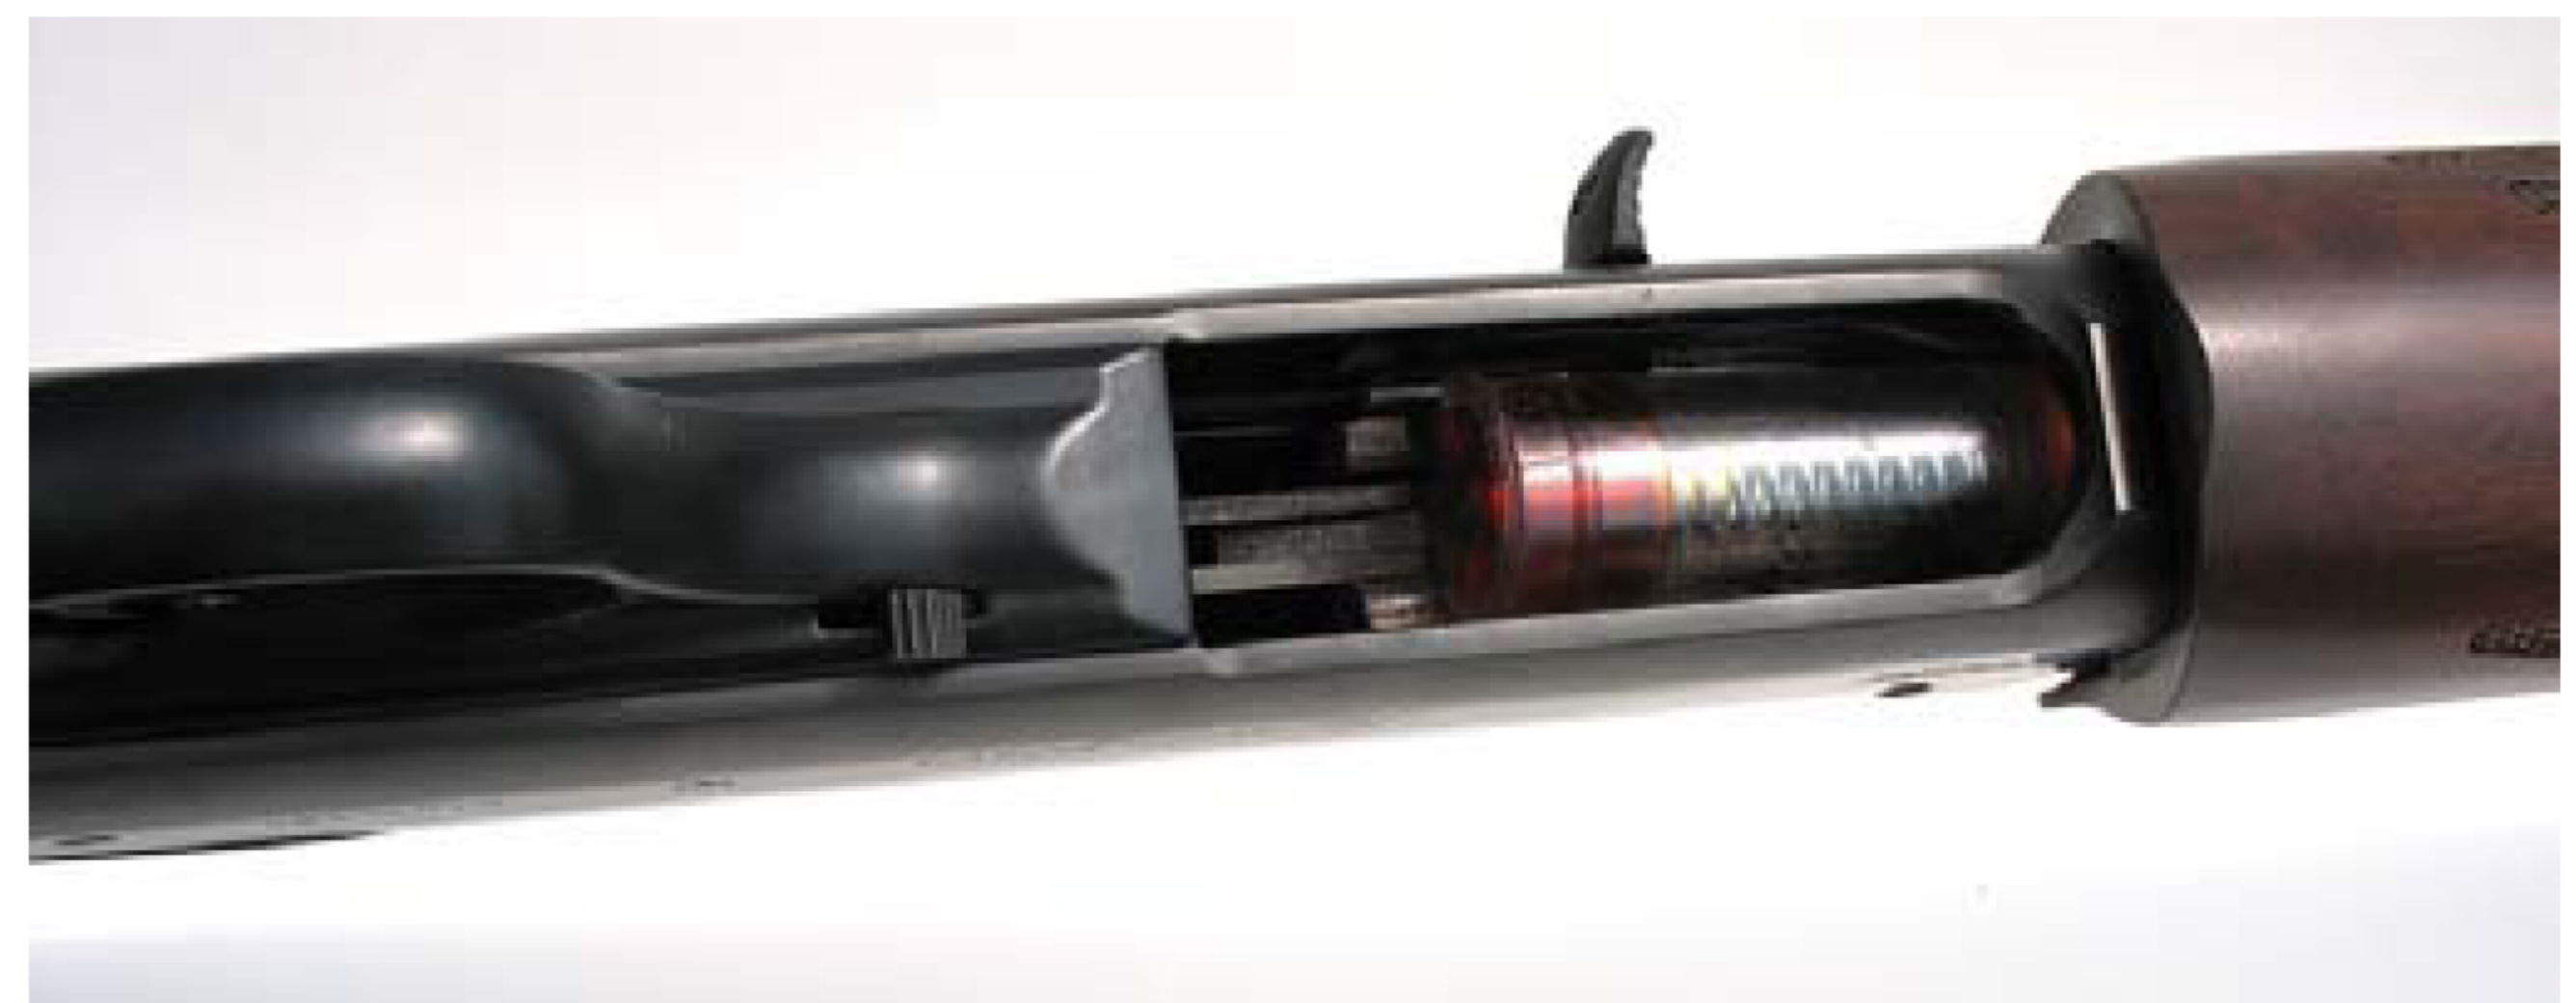
With the aid of a snap cap, you can see why loading the 105 can be problematic. The magazine tube is not in line with the breechblock, so a shell dropped into the bottom of the 105, or held against the 105 breechblock from below, cannot be smoothly loaded—it hits the receiver when pushed forward and cannot feed into the magazine.

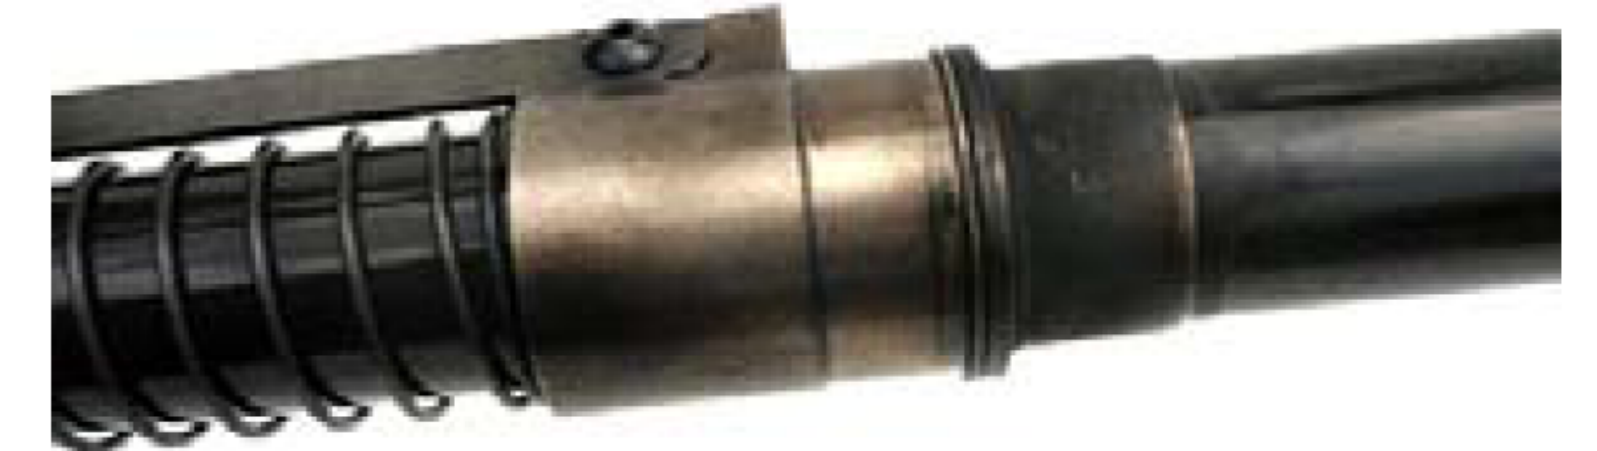
The rework of the 105 II is substantial. Internal modifications include changes to the action sleeve, action sleeve seal, bolt head, gas cylinder, and improved gas seals. Most of these parts have received nickel plating and Teflon coating. A look at the 105's gas flange at right shows how coated with residue it became after a cleaning and one box of shells fired. It is as far removed from “self-cleaning” as can be imagined. There are more than 70 documented steps to disassemble, clean, and reassemble the 105CTi II.
