## REMINGTON M887 NITROMAG NO. 82500 3½-INCH 12 GAUGE, \$399

## GUN TESTS GRADE: D

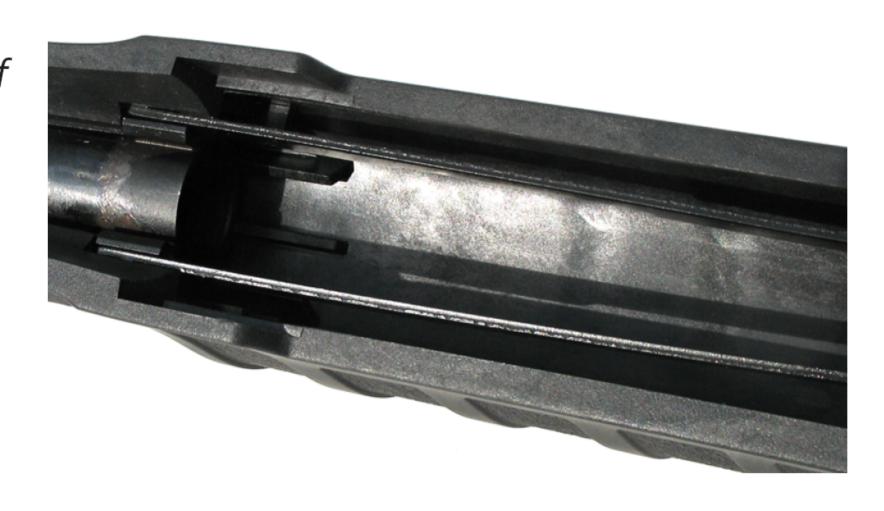
Right: As rough as we discovered the machining of the barrel to be, its mating surface inside the receiver was just as bad. Left: It is apparent from inspecting the inside of the receiver that most of this "steel receiver" is not metal at all—instead, it's thick plastic with visible mold

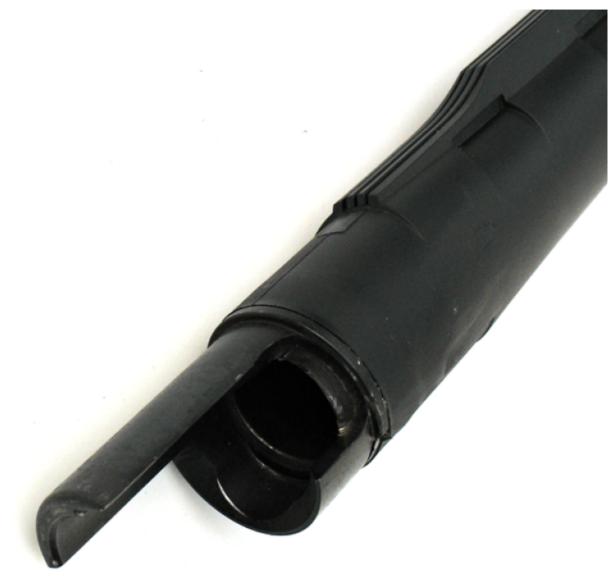
lines and plastic flashing pieces hanging off.
